Navajo Abandoned Uranium Mine Site Screen Report

Yucca AUM Site

Navajo AUM Eastern Region

May 2009

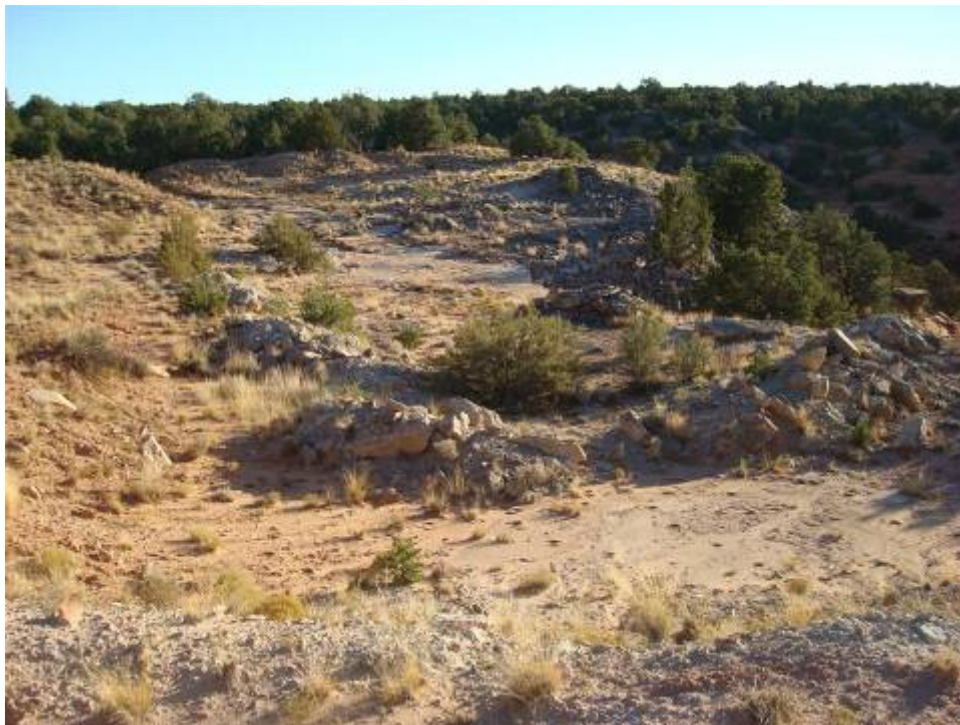
Photo 1. Yucca Mine site, towards the south

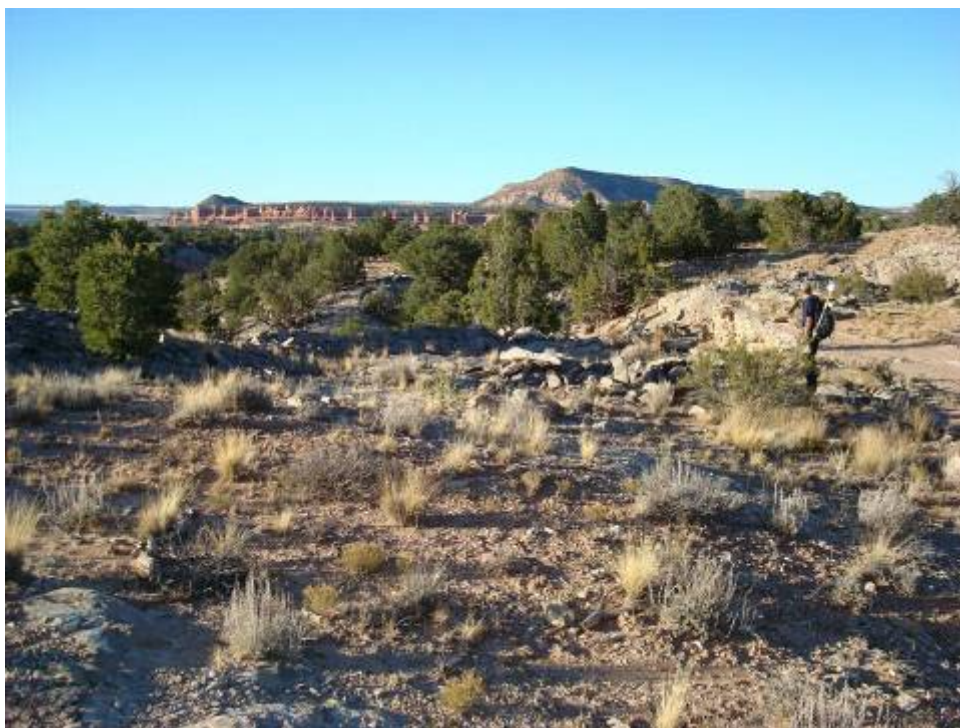
Photo 2. Yucca Mine site, towards the north

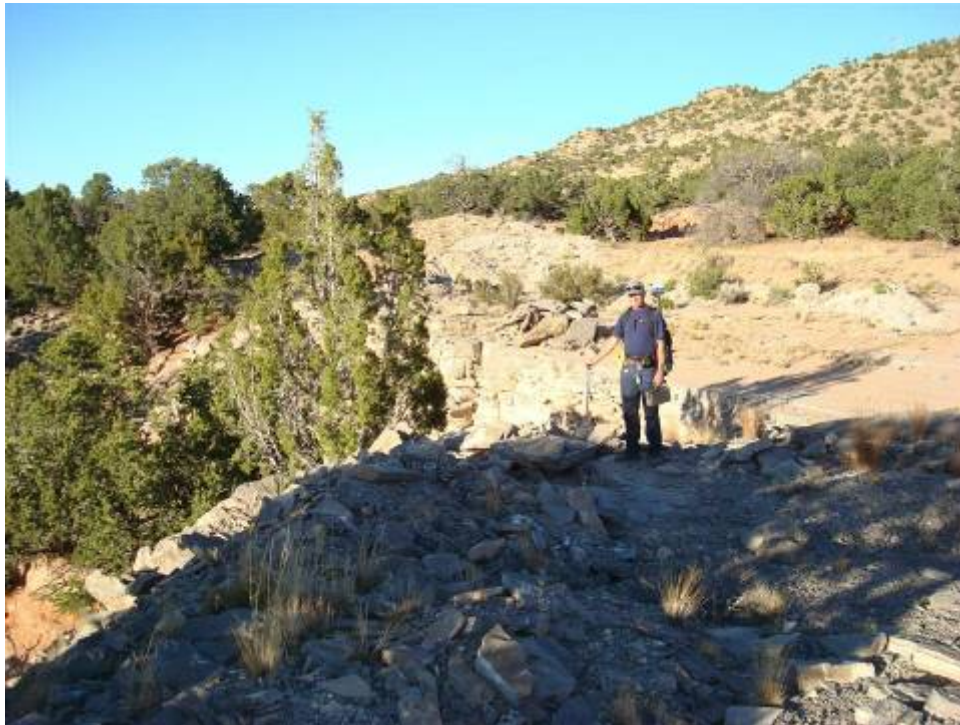
Reclamation status of the mine sites are currently unknown. No visible signs of reclamation were observed. Numerous waste rock piles are found throughout the site. The mining appears to have been conducted from exposed bedrock at the surface. No adits or other mine features were observed during the site visit.

Photo 3. Yucca Mine site, waste rock piles

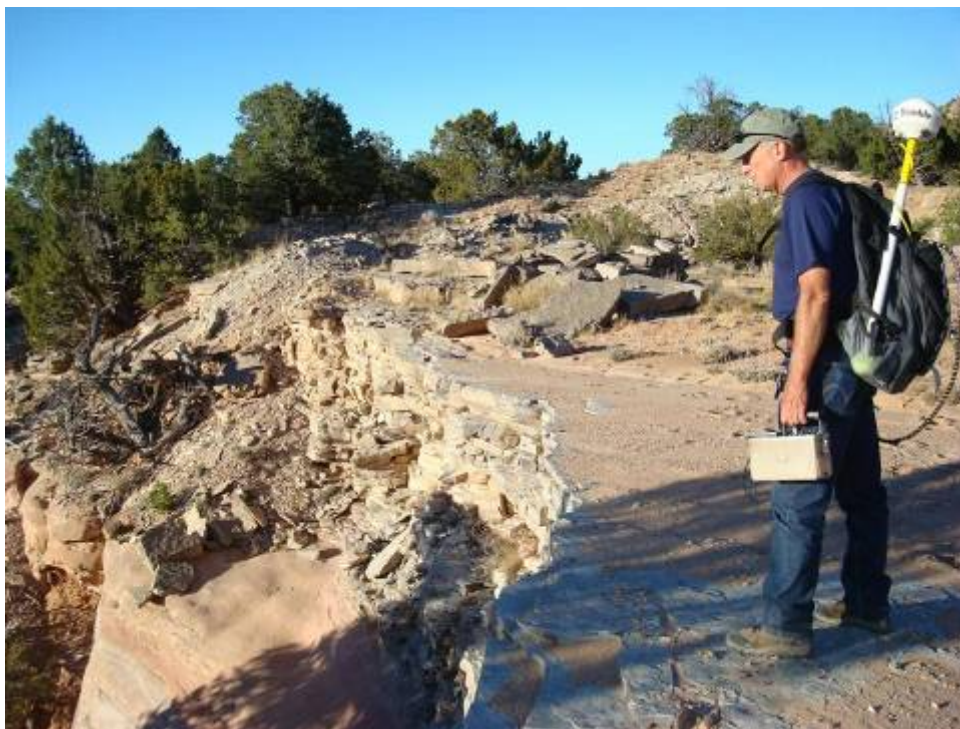
Photo 4. Yucca Mine site, waste rock piles pushed off mesa into a box canyon

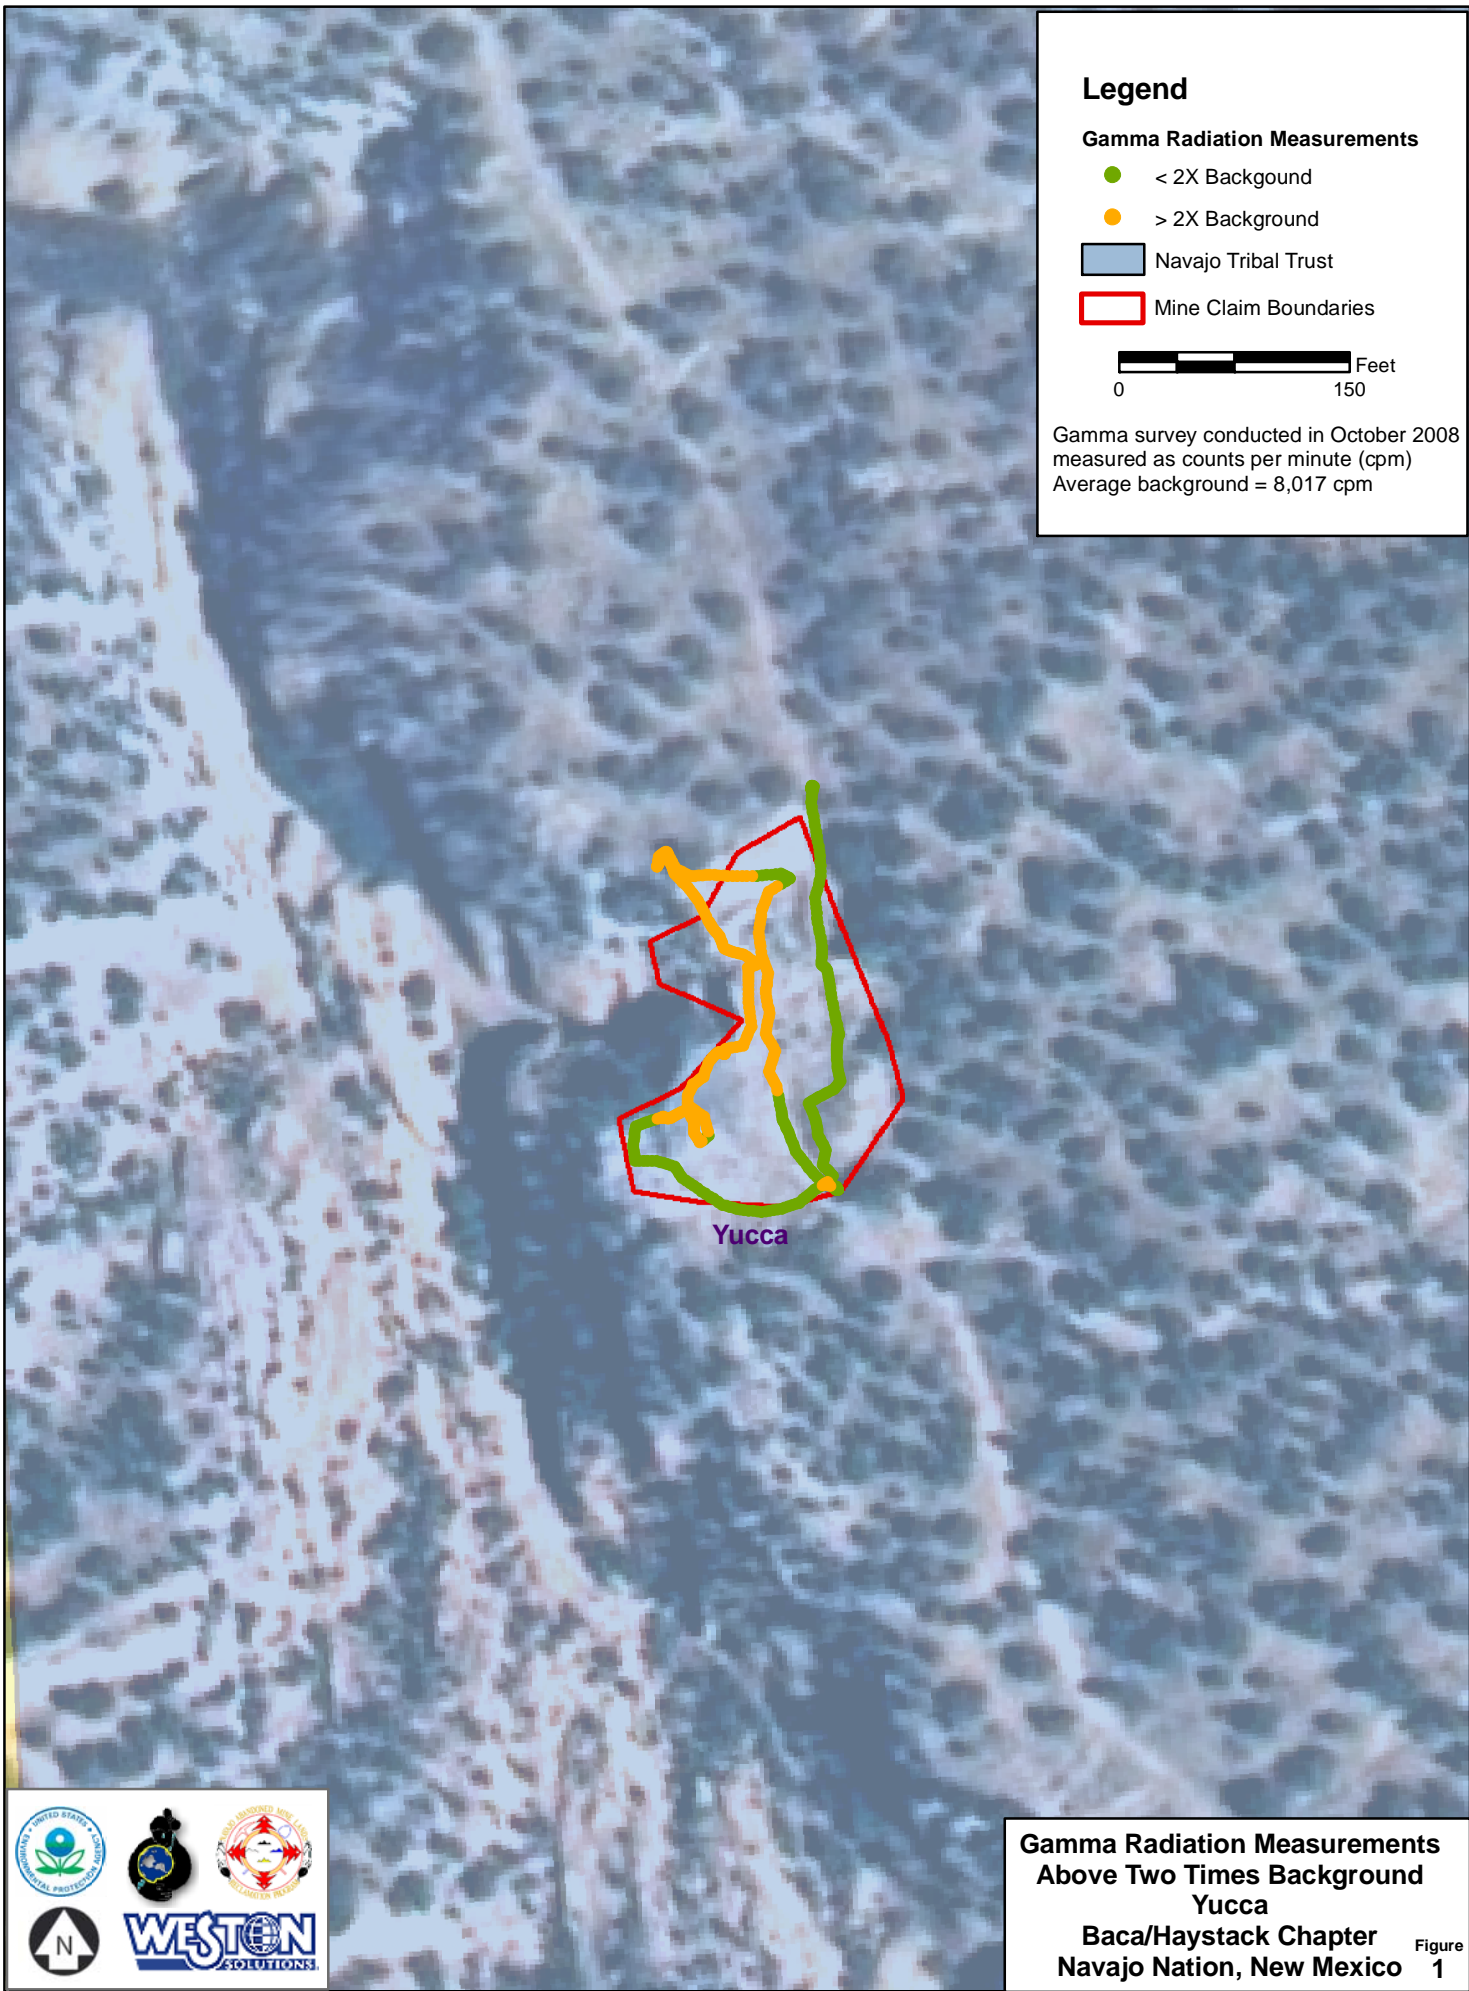
A total of 655 gamma radiation measurements were collected from mine sites, ranging from 6,341 cpm to 259,261 cpm. The measurements are represented in Figures 1 and 2. Radiological measurements collected for the New Mexico Mining and Minerals Division during a 2008 field screening survey found gamma radiation levels near the ground surface with a maximum of 220 micro Roentgen per hour ($\mu\text{R/hr}$) and a minimum of 9 $\mu\text{R/hr}$, levels at the 4-foot elevation with a maximum of 160 $\mu\text{R/hr}$ and a minimum of 10 $\mu\text{R/hr}$, and background levels of 10 $\mu\text{R/hr}$.

Gamma survey conducted in October 2008
measured as counts per minute (cpm)
Average background = 8,017 cpm

**Gamma Radiation Measurements
Above Two Times Background
Yucca**
**Baca/Haystack Chapter
Navajo Nation, New Mexico** Figure 1

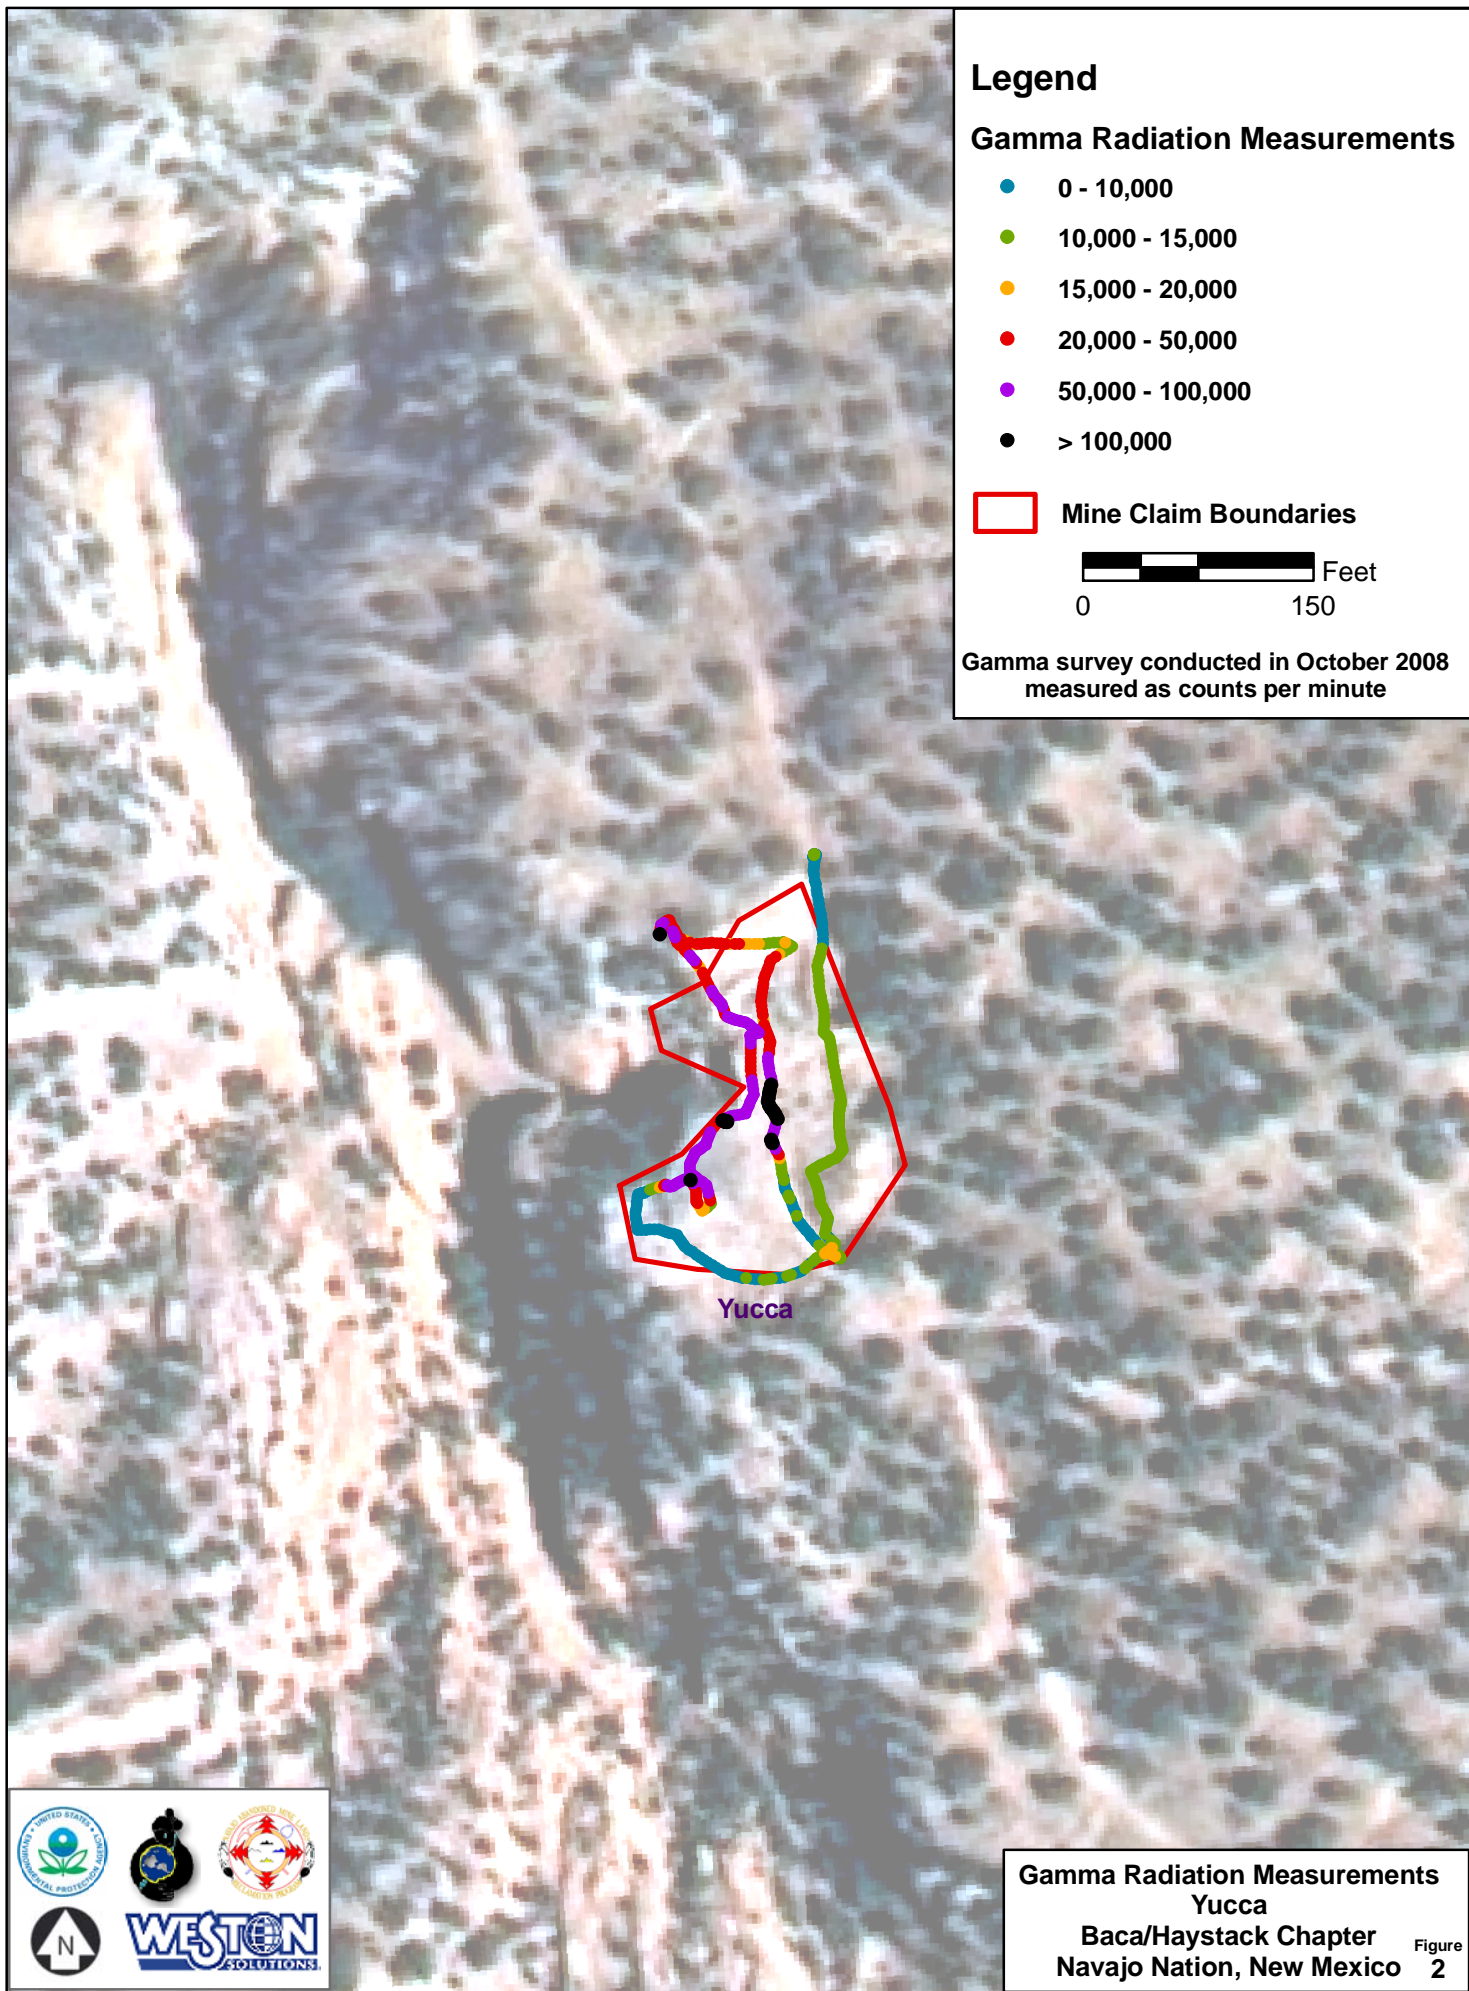
Figure
2

Gamma survey conducted in October 2008
measured as counts per minute

Gamma Radiation Measurements
Yucca
Baca/Haystack Chapter
Navajo Nation, New Mexico
